## SERVICE INSTRUCTION no. 2012/4 – revision 1

### Reduction of condensate water at Ignis burner

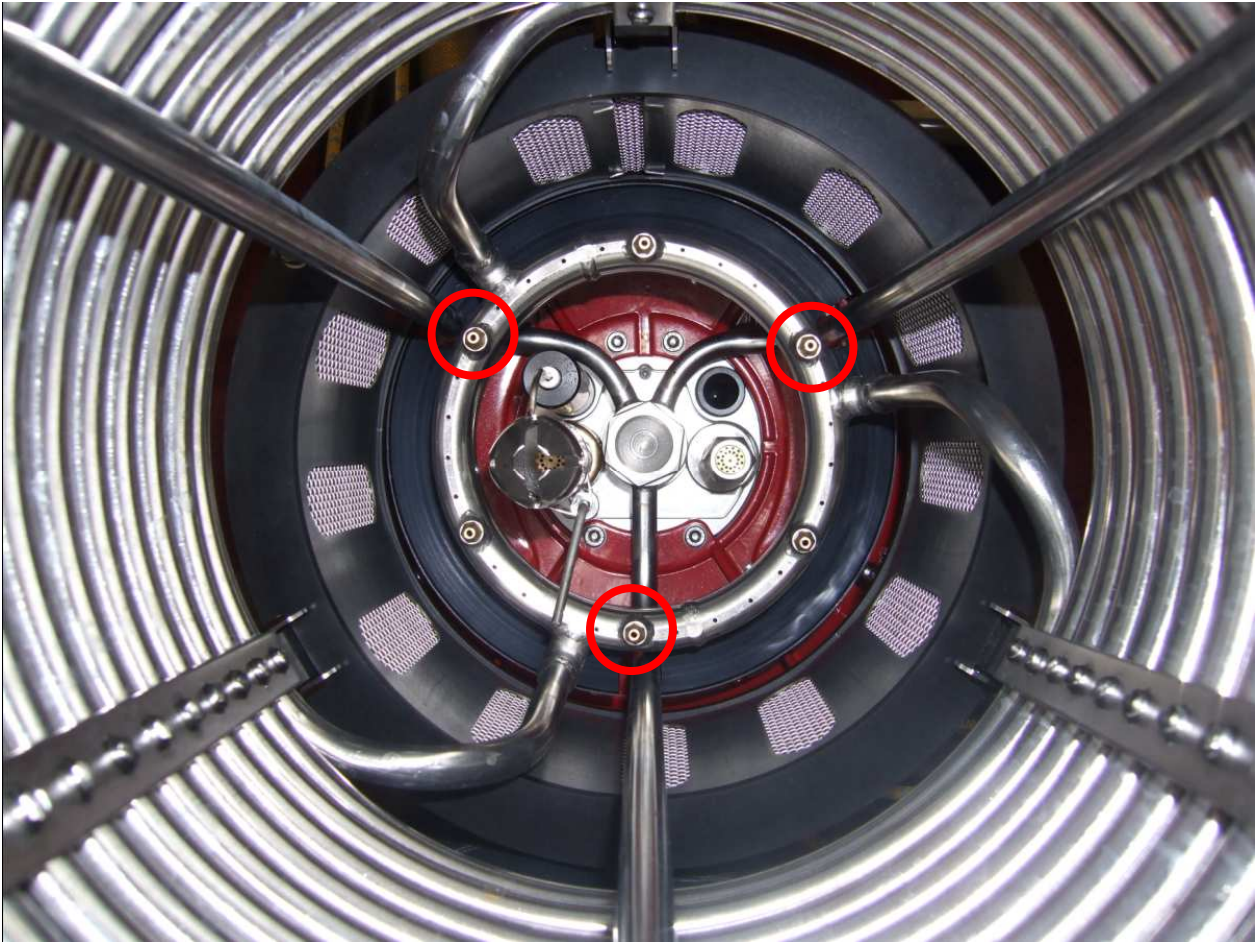
- With reference to:** Burner units of serial numbers from 598
- Reason:** Operation of Ignis burner using pure propane pressurised close to maximum pressure can cause increased generation of condensate water
- Solution:** Propane flow through coil to be reduced using 1 – 6 blind jets instead of standard jets supplied with the burner. Replacing of 3 jets marked on fig 1 is a preferred option.

Fig 1 – Jets to be replaced

1. Unscrew the jet(s) using wrench key, size 6 (Fig 1)
2. Replace the jet(s) with the blind jet (part no. 54255.00; Fig 2)
3. Fix the blind jet thread using Loctite 620 (part no. 3122.00)

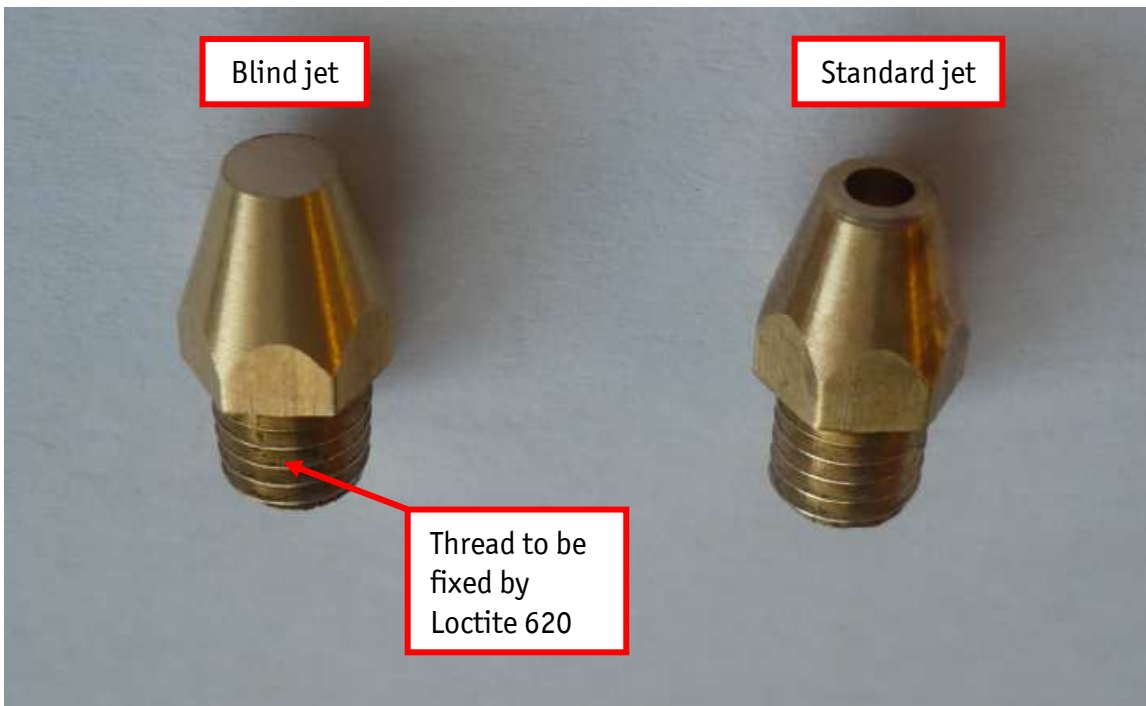
Fig 2 – Blind Jet to be mouted in
