**SERVICE INSTRUCTION no. 2013/01**  
**Increasing of efficiency of Paralite deflation system**

**With reference to:** Kubicek XR envelopes equipped by Paralite of serial numbers: 918, 962, 978, 983, 989, 993, 1010, 1016, 1022, 1024, 1025 and 1030.

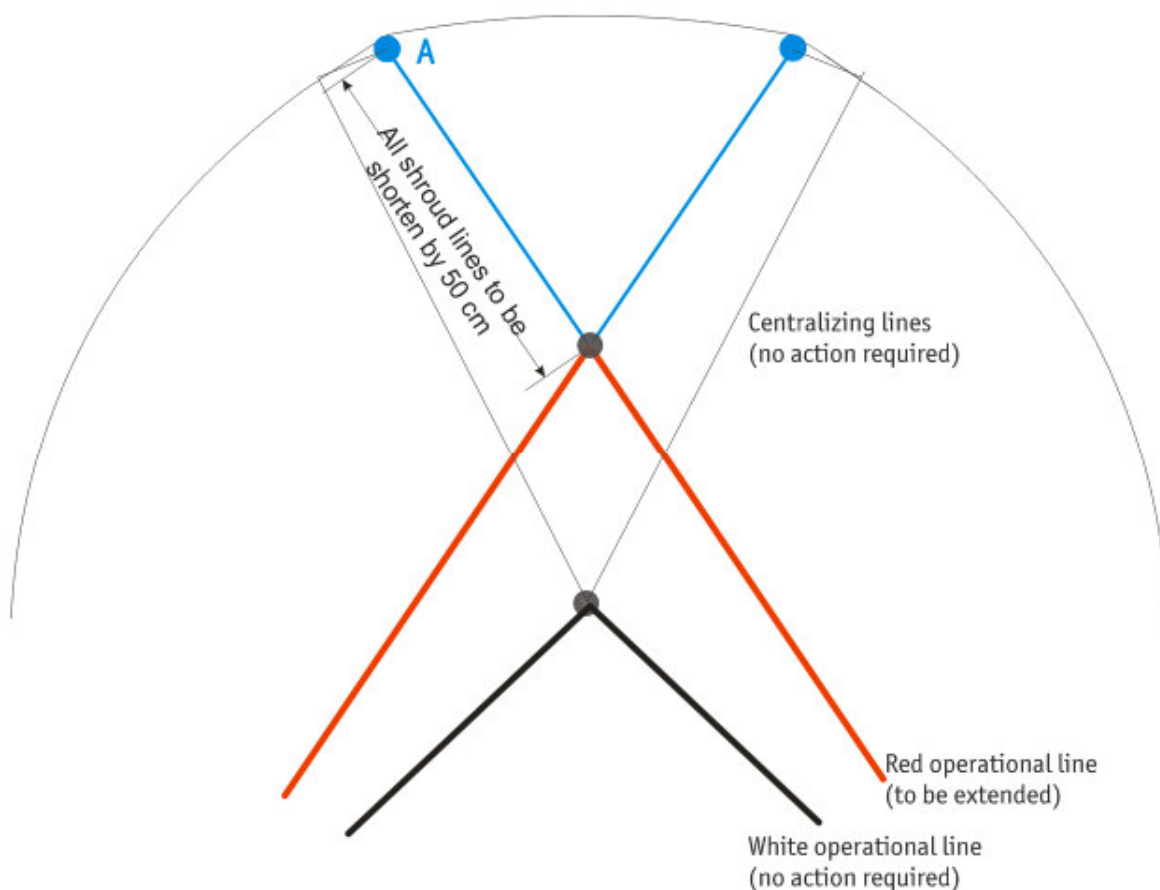
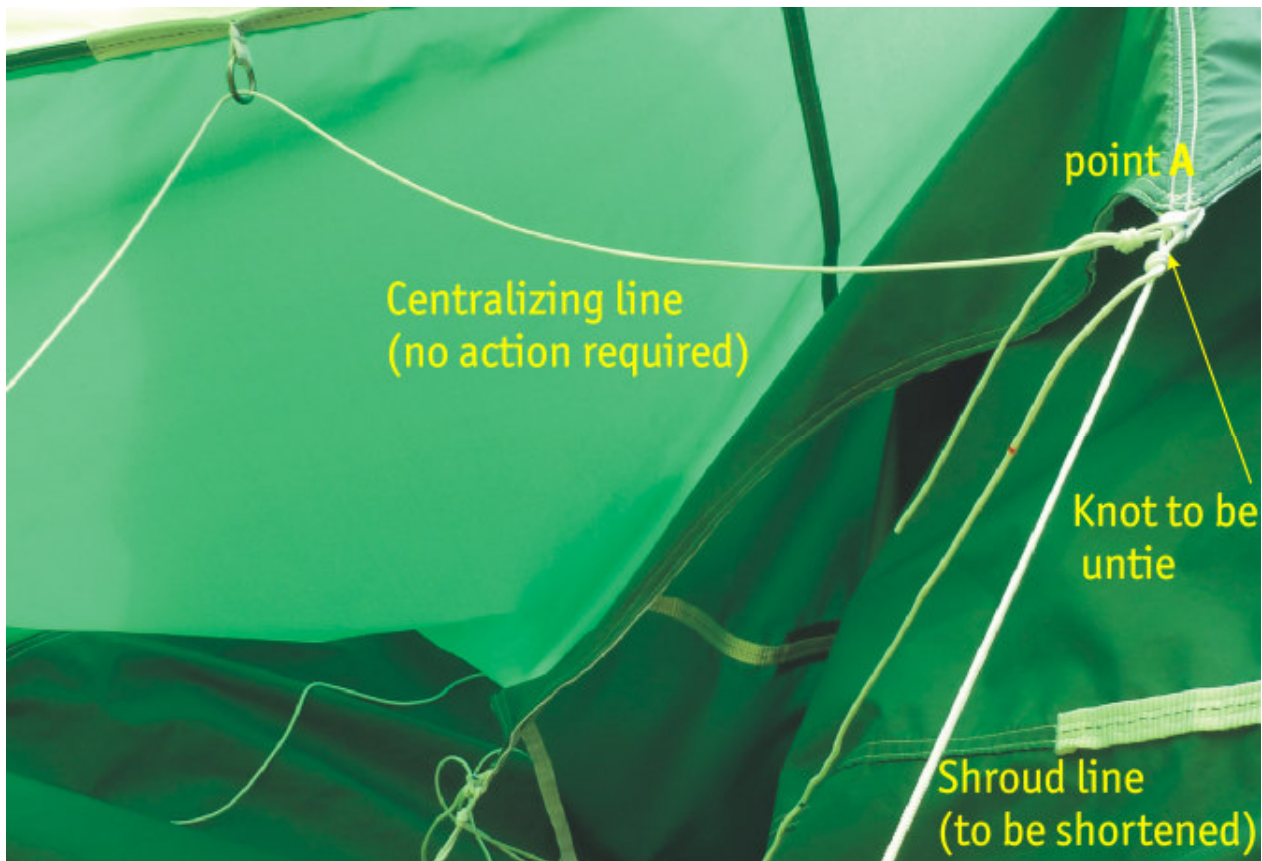
**Cause:** Feedback from operators.

1. Shorten the shroud lines by 50 cm. Untie the line in point A (see the following picture and photo), cut the line by 50 cm and tie it again
2. Extend the red operational line by 1.5m (BB20XR) and 1.5 m (BB22XR, BB26XR, BB30XR). Use the reserve inside the envelope. If the reserve is not long enough a new operation line must be fitted in.
3. Perform a test inflation according to Maintenance Manual B.2202 (B.2205 for US registered balloons) 7.19.4
