SERVICE INSTRUCTION no. 2017/01
Increasing of Slide vent deflation system efficiency

With reference to: Kubicek envelopes BB34(Z,D,N)-BB45(Z,D,N) equipped by Slide vent
Note: This modification is incorporated by the manufacturer for more recent envelopes.

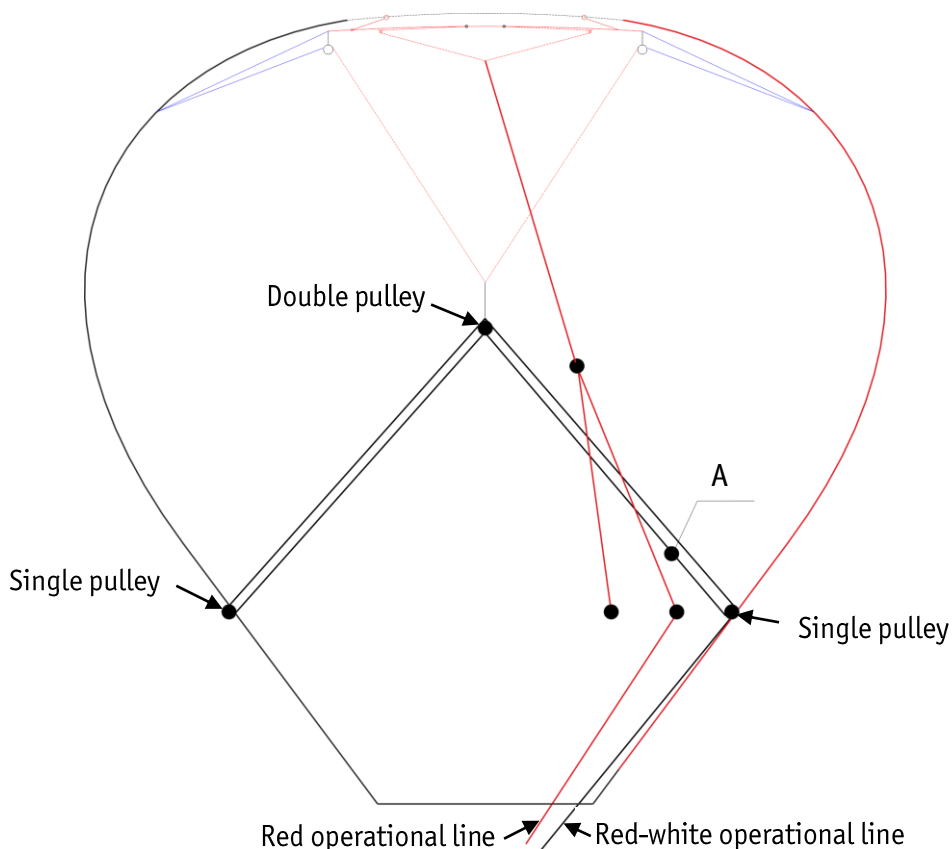
Before:

1. Untie the red-white operational line in point A (see following picture), shorten the red-white operational line by cutting off the length defined in table:

2. Pull out the line from the pulleys. Replace the double pulley with single pulley.
3. Pull the line through the pulleys and tie.
